CROWE BRIDGE CONSERVATION AREA TRAIL STUDY

Prepared for The Friends of Crowe Bridge Park

John Marsh and Allen MacPherson

Trail Studies Unit

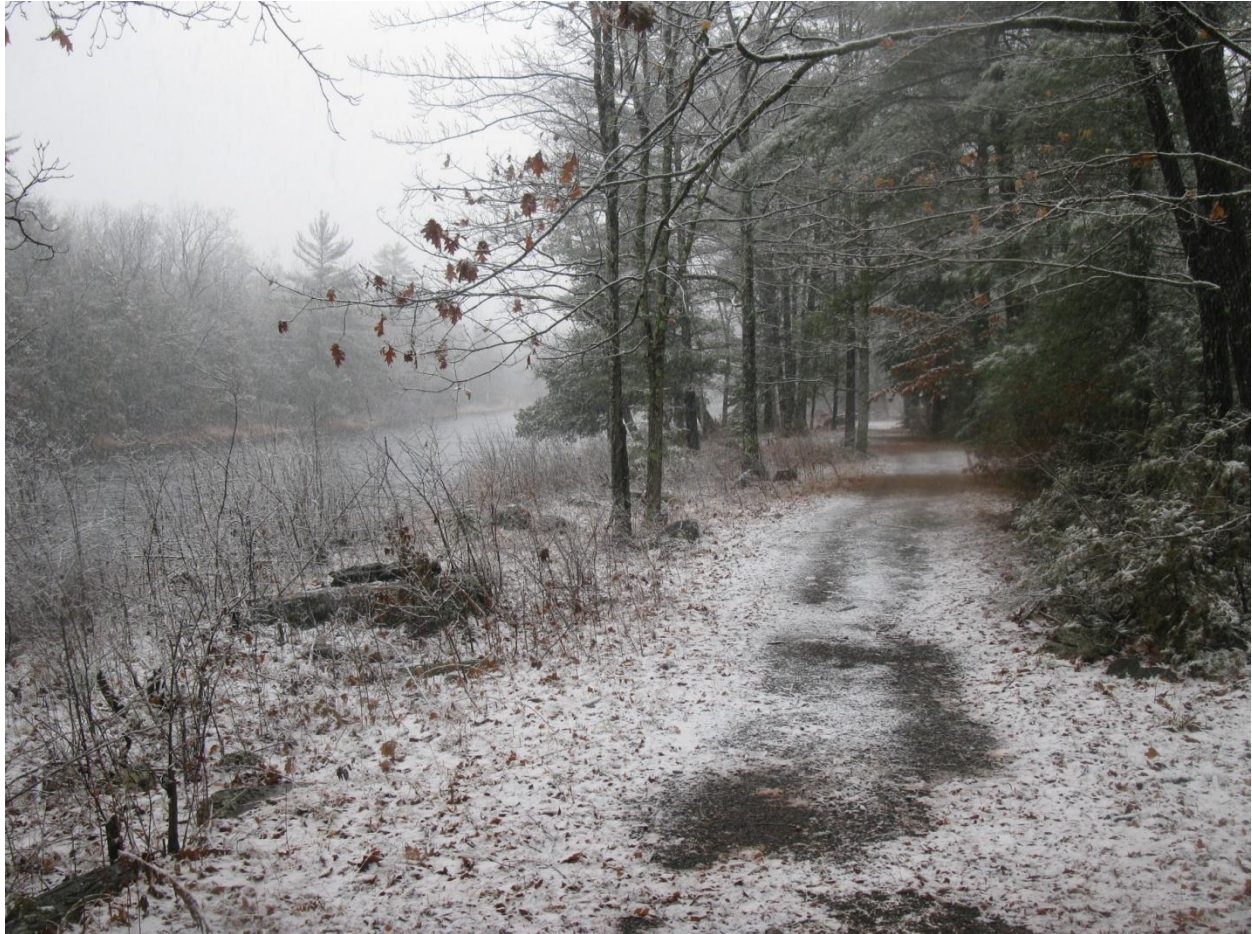
Numerous digital photos of the trails and other built and natural features in the conservation area were taken in the Fall, Winter and Summer seasons. A selection of these has been provided on a CD. The students from Fleming also took some excellent digital photographs which have been included with their submission on CD.

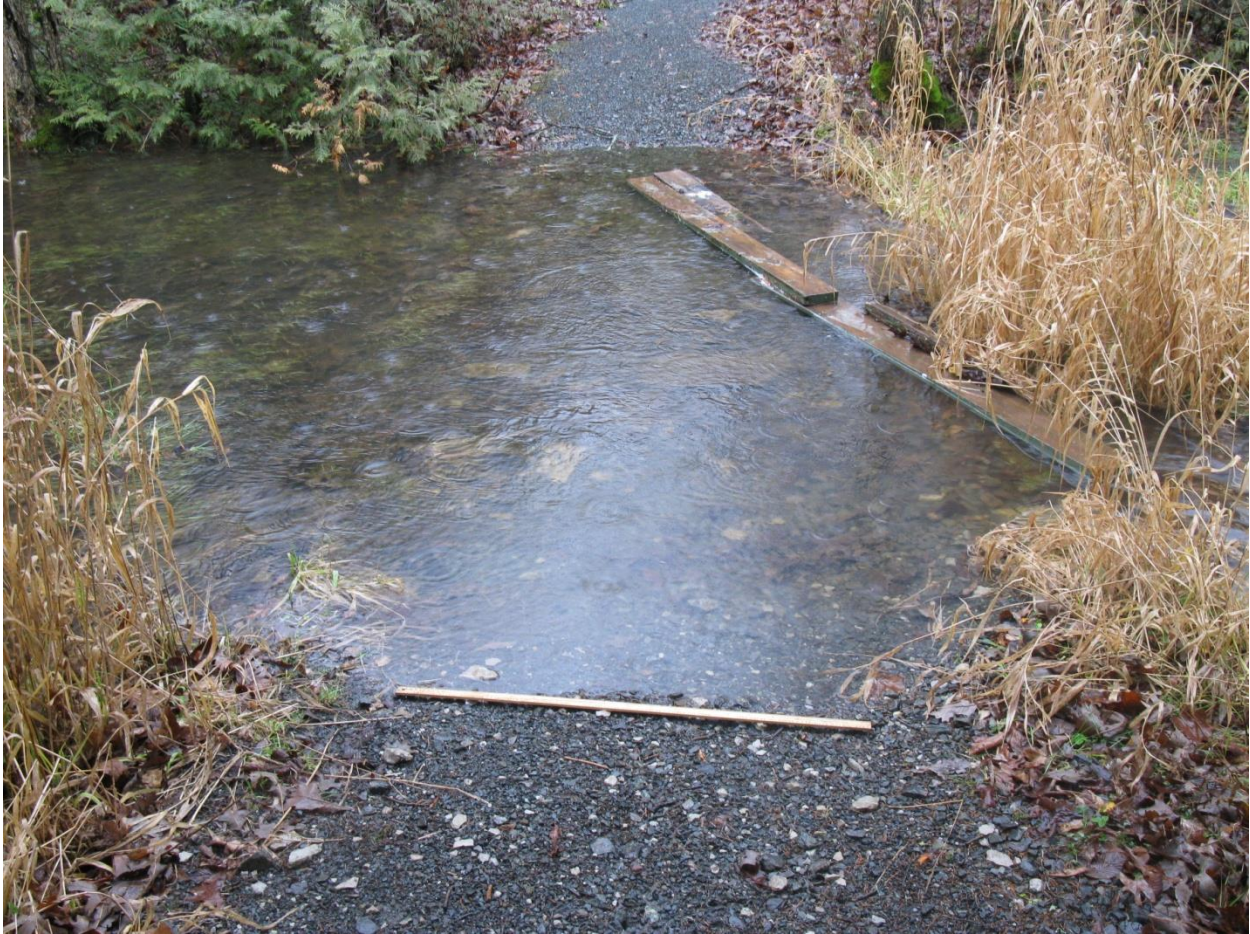
- At 174 metres from beach trailhead the trail crosses a creek which can be at least 3 m wide, 10 cm deep. Some planks have been put across (see photo). A bridge is needed here.
- At 80 and 104 metres from beach trailhead the trail is 10 degrees or steeper. Grade needs to be reduced here.
- At 225 metres from beach trailhead, where trail crosses small gully, the east edge of the trail is 10 cm below centre. Trail needs leveling here.
- At 232 metres from beach trailhead there is a sharp bend in the trail where ATVs have caused ruts 10 cm deep. Trail needs leveling here.
- The trails leading off the main trail from the beach trailhead to the entrance east to the road, and west to the river have several sections with grades steeper than 10 degrees, and ruts on corners.
- More limestone screenings need to be added where underlying soil is exposed.

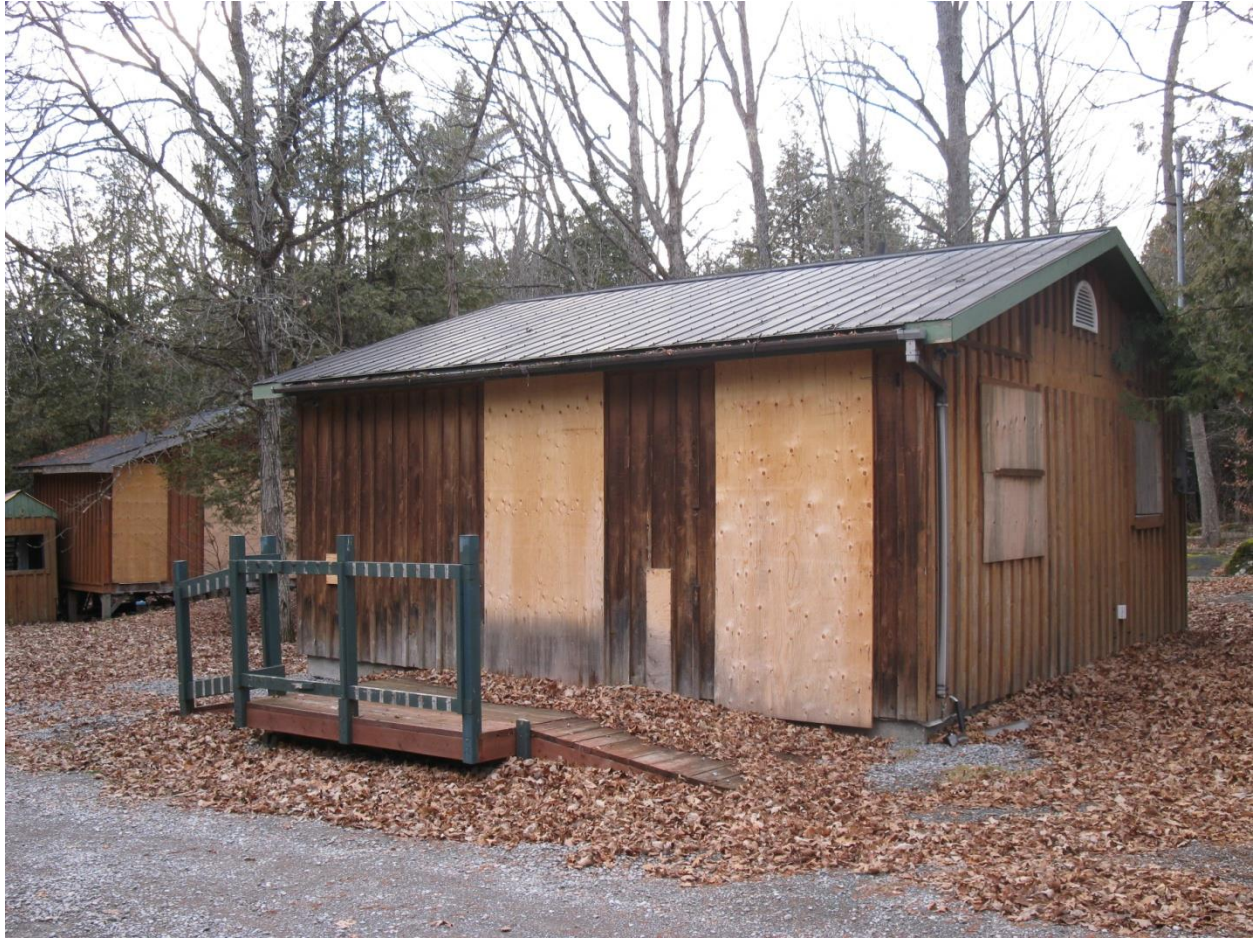
There are various buildings, now disused, but boarded up and in relatively good condition, in both sections of the conservation area. These might have a use that complements the trails and conservation area generally. It may be desirable to keep a building at the entrance to the southern section and another at the entrance to the northern section. The outer walls of each could be used for exhibiting maps, regulations, emergency information and interpretation materials. They could also be used by any seasonal staff or volunteers that might in future be located in the conservation area. One might even be suitable as a small visitor/interpretation centre. However, retention and use of these buildings would require maintenance, security and vandalism to be addressed.

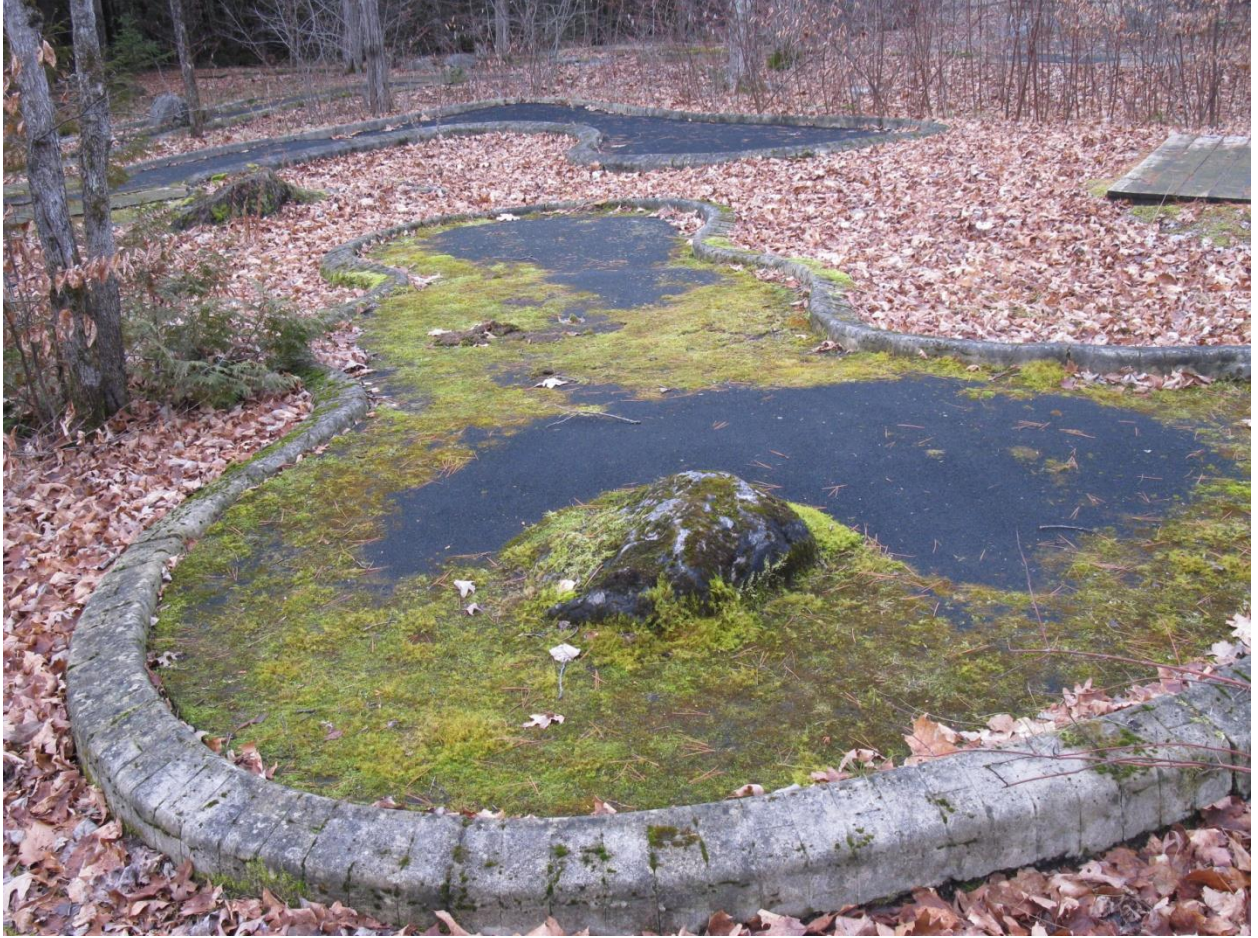
The mini-put golf course near the entrance to the southern section was well built and, with relatively little work, could be renovated for use. If this were to be done, all of the trails running around it would have to be retained and maintained.

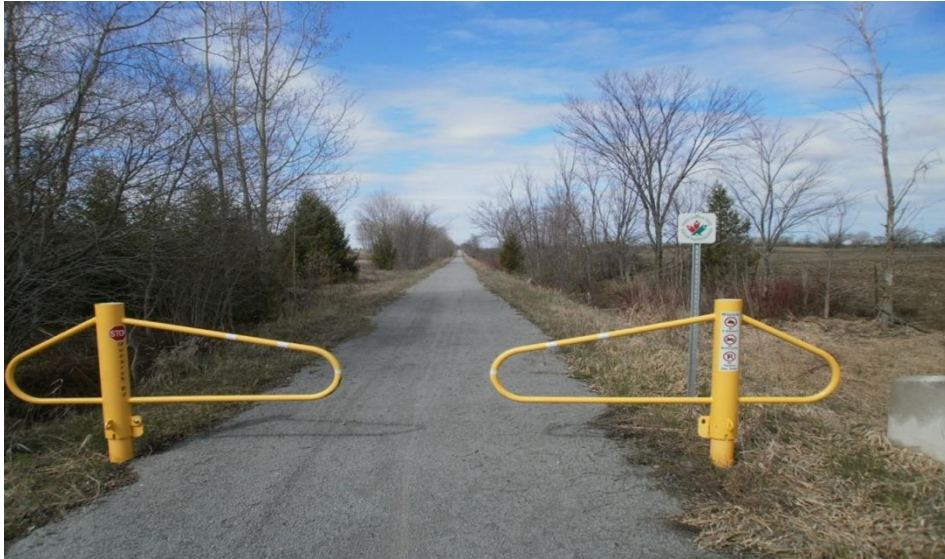
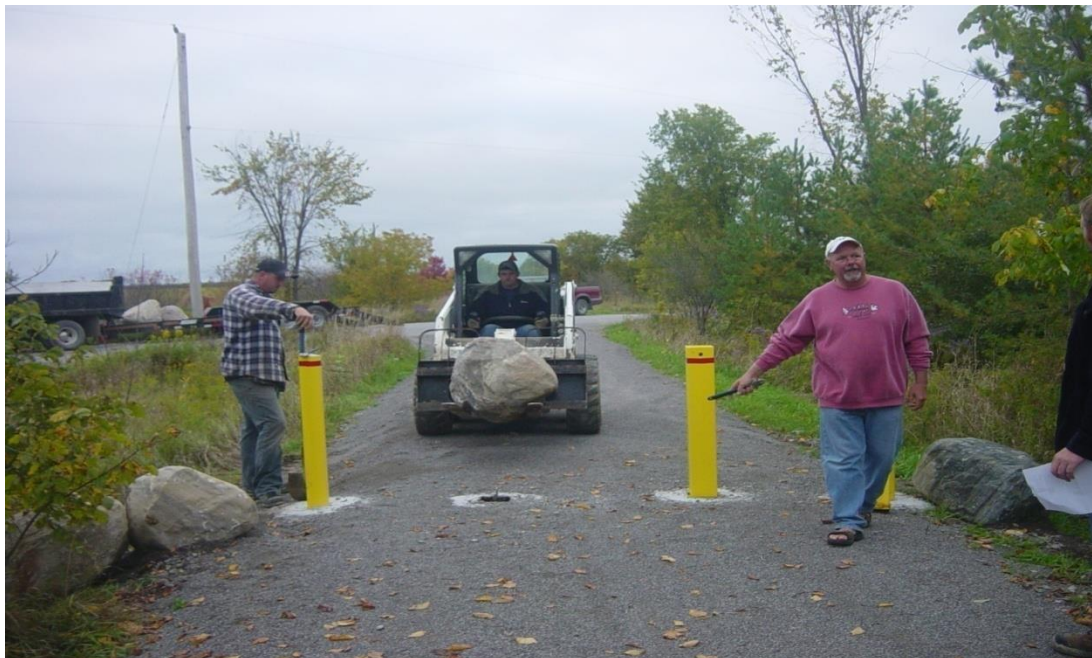
Removal bollards – stones are used to prevent vehicles from going around bollards. Sight lines are long and straight with proper signage installed. Bollards are yellow with reflective tape. Sticker signs are placed on Bollards indicating no motorized vehicles. (Kawartha Trans Canada Trail, 2009)

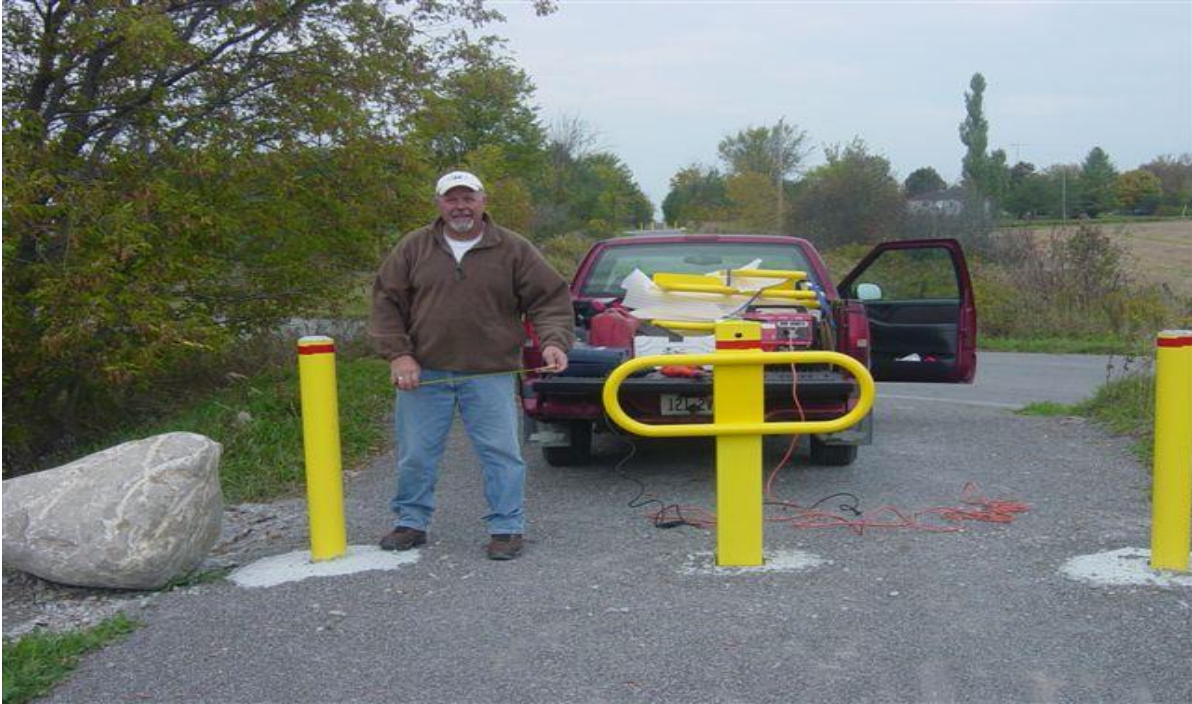
Two round bollards and one square bollard (removal) with side arms attached that are removal. This allows to have one bollard installed and reduces the distance between the other bollards to restrict motorized use but allow for cycling and horseback riders access. (Kawartha Trans Canada Trail 2009).

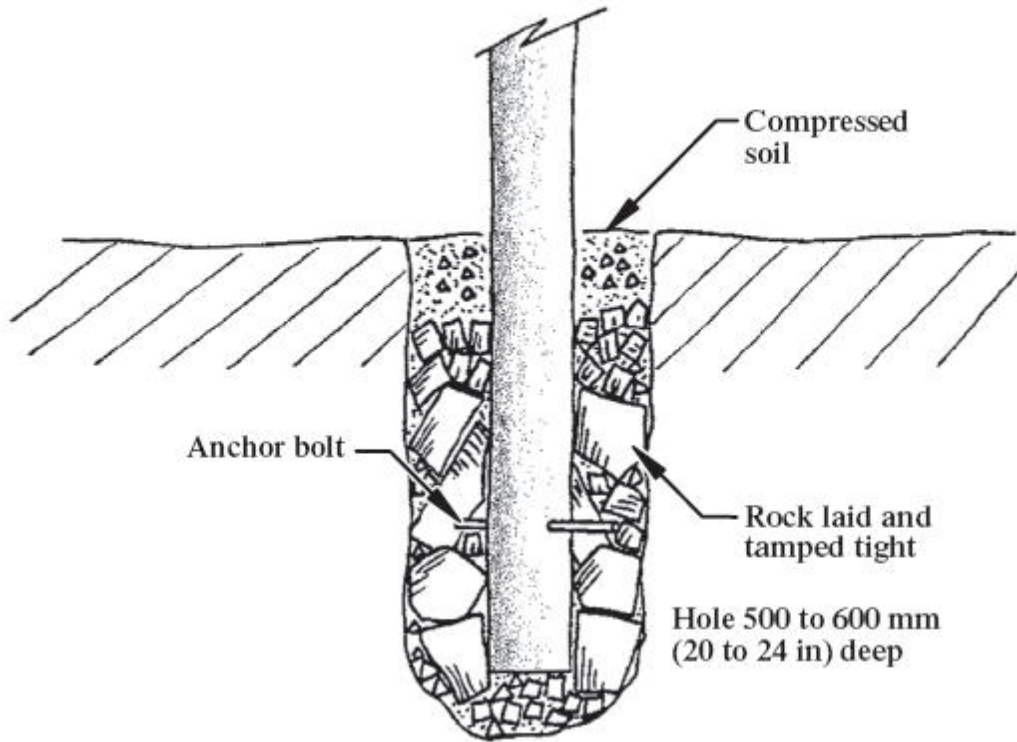
Signpost Installation

Signs needing their own support should be installed using one or two 4"x4" posts eight feet long placed approximately 24" into the ground with a theft-resistant anchor bolt. Postholes should be filled with either concrete or rocks and covered with compressed soil. The sign should be attached to the post using theft-resistant, corrosion-resistant hardware such that the top of the sign is level and even with the tops of the signposts

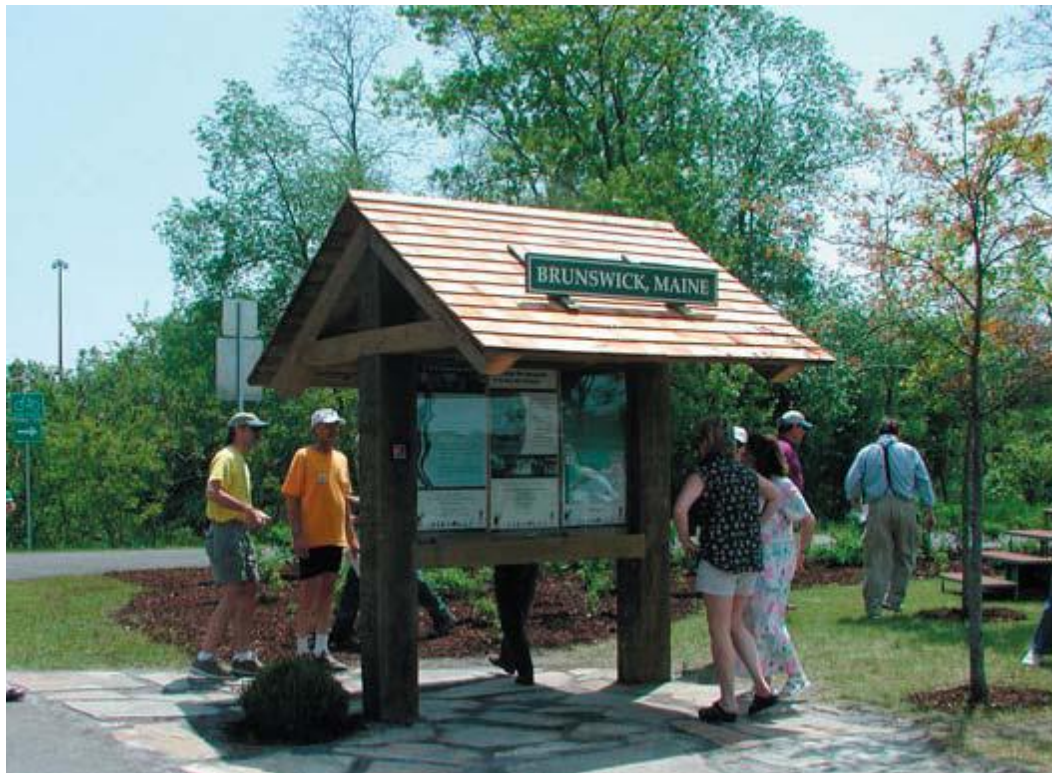
Design specifications suggested design for Crowe Bridge includes a single panel on each side of the kiosk. Although these designs accommodate 32"x48" panels, the size and style of the kiosk can vary depending on what is needed for each specific site. For example, a bulletin board could be included for patrons to post temporary notices, or a single large panel could accommodate several smaller signs. Be sure that the kiosk is designed to accommodate the needs of its intended location.
